Customer : M/s Aakar Foundry

**Thermal Insulation Coating to
LPDC Holding Furnace 2**

**Thermal Insulation Coating Completion Dates : 16th & 25th January, 2018
“Before & After” Thermography Dates : 9th Oct, 2017 & 14th March, 2018**

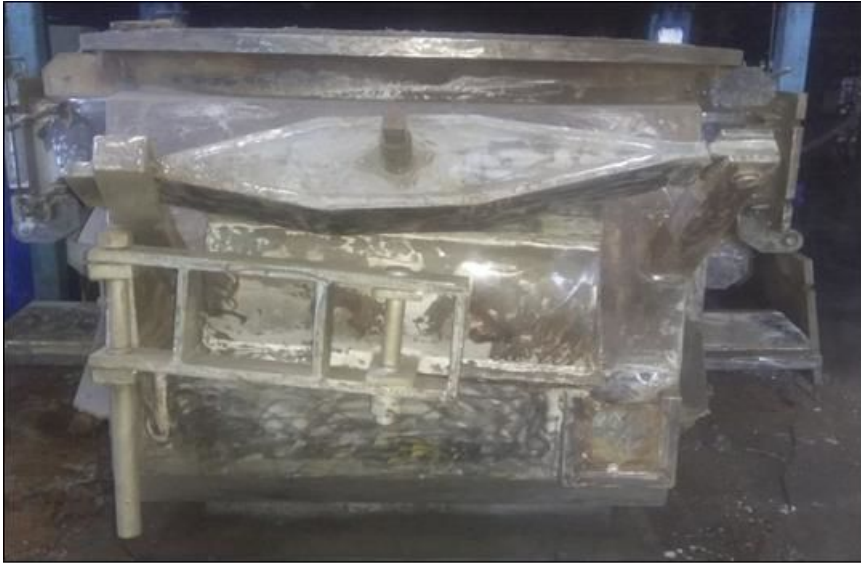
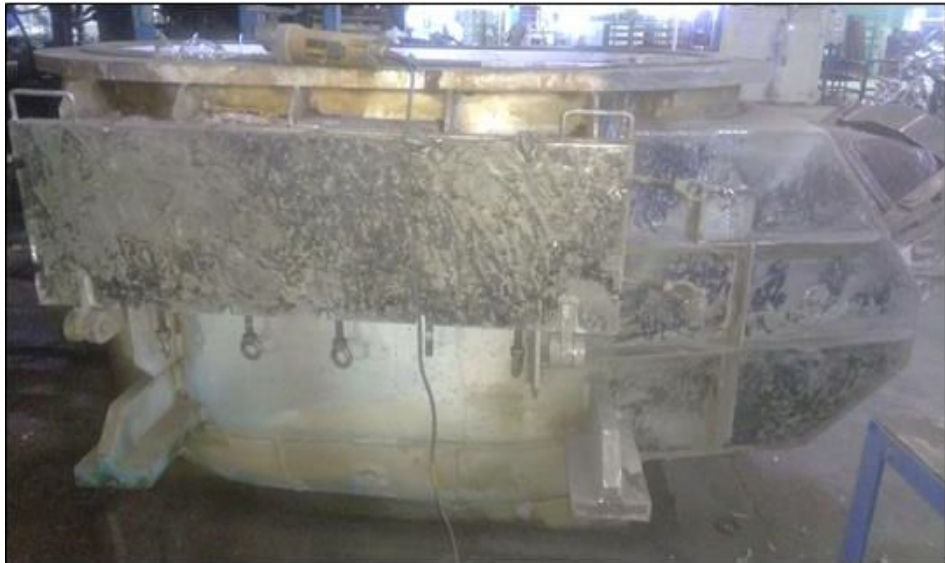
Before HRTI 400 Coating

LPDC Holding Furnace 2 : Cleaned earlier coating & dust

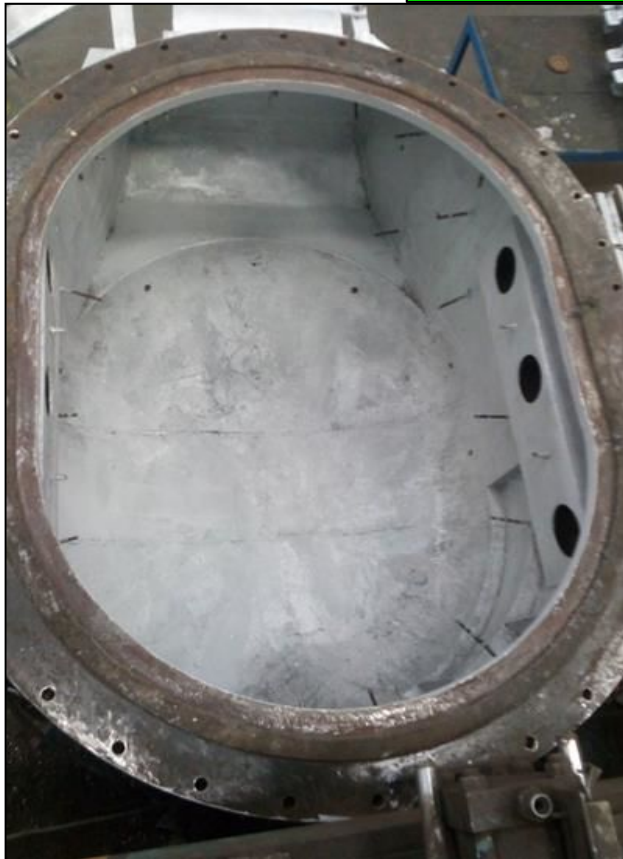
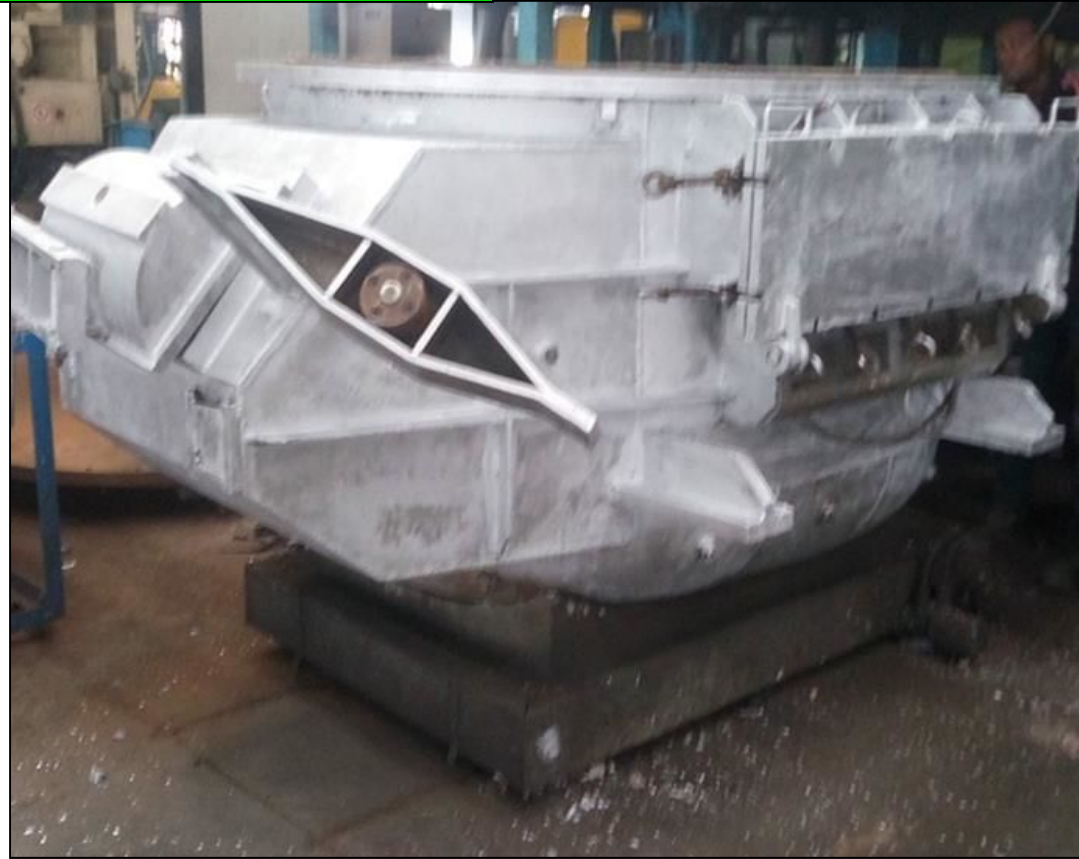
After HRTI 400 Coating

LPDC Holding Furnace 2 : Thermal Insulation Coating HRTI- 400 done to inner & outer surface of shell (3 layers)

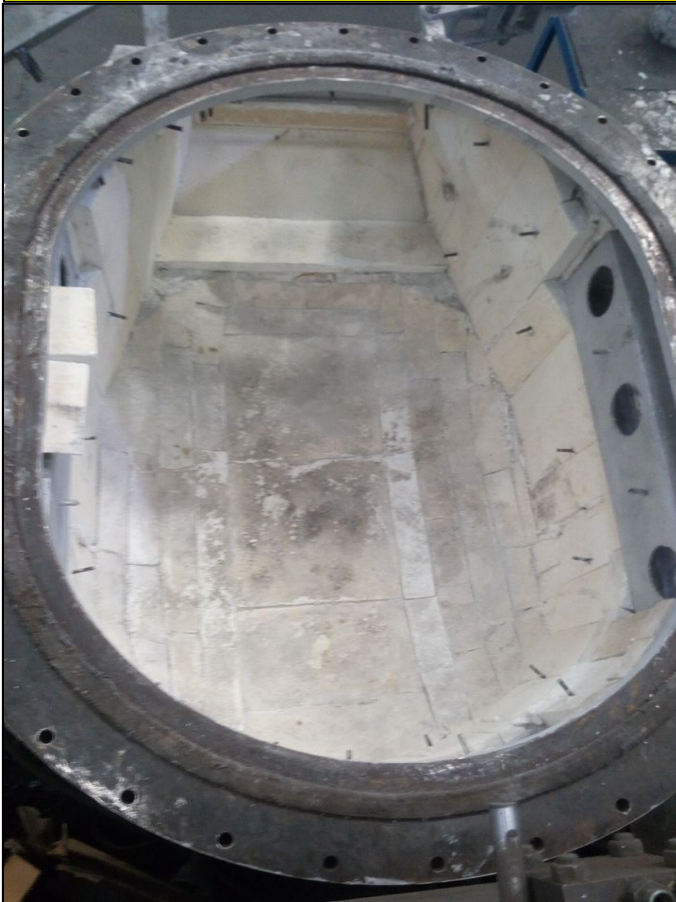
Before HRTI 1200 Coating

LPDC Holding Furnace 2 : Thermal Insulation Coating HRTI- 1200 done on Cold Lining by Ceramic Boards (3 Coats)

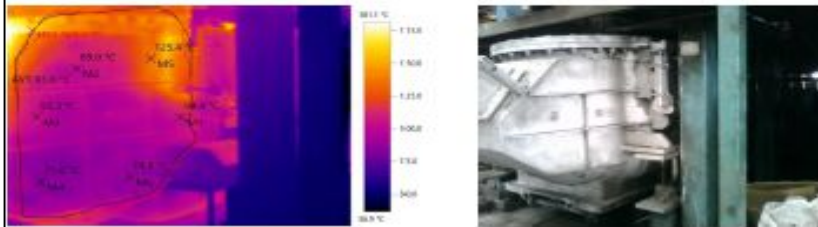
LPDC HF 3 Without Coating

File: 3 BEFORE IR001090 LPDC HF 3 ANGULAR SIDE.BMT Date: 09-10-2017
 lens type: 35° x 25° lens serial no.: Time: 12:29:05

Measurement Objects	Temp. [°C]	Emiss.	Refl. temp. [°C]	Remarks
Measure point 1	94.4	0.96	20.0	CenterSpot
Measure point 2	89.0	0.96	20.0	-
Measure point 3	93.3	0.96	20.0	-
Measure point 4	71.6	0.96	20.0	-
Measure point 5	125.4	0.96	20.0	-
Measure point 6	74.6	0.96	20.0	-
Hot spot 1	160.3	0.96	20.0	-
Average Area 1	93.9	0.96	20.0	-

Location	Before Coating	After Coating	Reduction in Temperature
Angular Side Max Temp	160.3°C	145.7°C	14.6°C
Angular Side Average Temp	93.9°C	86.3°C	7.6°C

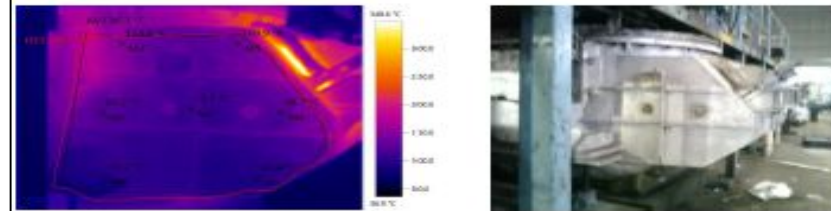
LPDC HF 2 With Coating

File: 4 AFTER IR003480 LPDC HF 2 ANGULAR SIDE.BMT Date: 14-03-2018
 lens type: 35° x 25° lens serial no.: Time: 17:16:48

Measurement Objects	Temp. [°C]	Emiss.	Refl. temp. [°C]	Remarks
Measure point 1	79.3	0.96	20.0	CenterSpot
Measure point 2	89.2	0.96	20.0	-
Measure point 3	114.4	0.96	20.0	-
Measure point 4	88.7	0.96	20.0	-
Measure point 5	100.9	0.96	20.0	-
Measure point 6	70.2	0.96	20.0	-
Measure point 7	69.6	0.96	20.0	-
Cold spot 1	47.7	0.96	20.0	-
Hot spot 1	145.7	0.96	20.0	-
Average Area 1	86.3	0.96	20.0	-

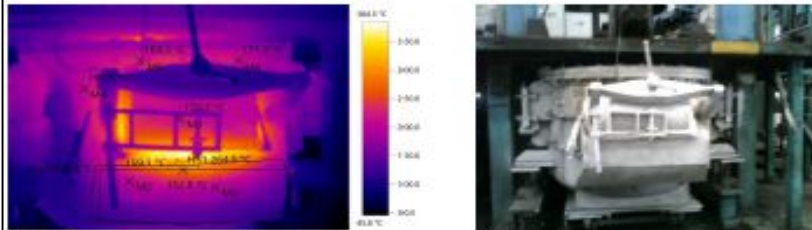
LPDC HF 3 Without Coating

File: 1 BEFORE IR001112 LPDC HF 3 METAL TAPPING DOOR .BMT Date: 09-10-2017
 lens type: 35" x 26" lens serial no.: Time: 12:40:49

Measurement Objects	Temp. [°C]	Emiss.	Refl. temp. [°C]	Remarks
Measure point 1	173.7	0.96	20.0	CenterSpot
Measure point 2	159.1	0.96	20.0	-
Measure point 3	152.8	0.96	20.0	-
Measure point 4	161.5	0.96	20.0	-
Measure point 5	169.3	0.96	20.0	-
Measure point 6	171.2	0.96	20.0	-
Hot spot 1	264.5	0.96	20.0	-
Average Area 1	141.8	0.96	20.0	-

Location	Before Coating	After Coating	Reduction in Temperature
Metal Tapping Door Max Temp	264.5°C	203.6°C	60.9°C
Metal Tapping Door Average Temp	141.8°C	105.4°C	36.4°C

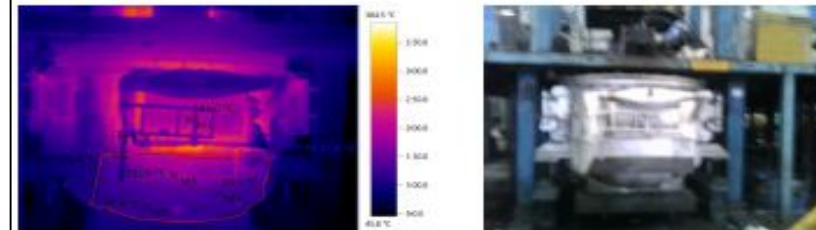
LPDC HF 2 With Coating

File: 2 AFTER IR003475 LPDC HF2 METAL TAPPING DOOR.BMT Date: 14-03-2018
 lens type: 35" x 26" lens serial no.: Time: 17:14:45

Measurement Objects	Temp. [°C]	Emiss.	Refl. temp. [°C]	Remarks
Measure point 1	141.0	0.96	20.0	CenterSpot
Measure point 2	110.5	0.96	20.0	-
Measure point 3	132.6	0.96	20.0	-
Measure point 4	95.1	0.96	20.0	-
Measure point 5	88.8	0.96	20.0	-
Cold spot 1	41.4	0.96	20.0	-
Hot spot 1	203.6	0.96	20.0	-
Average Area 1	105.4	0.96	20.0	-

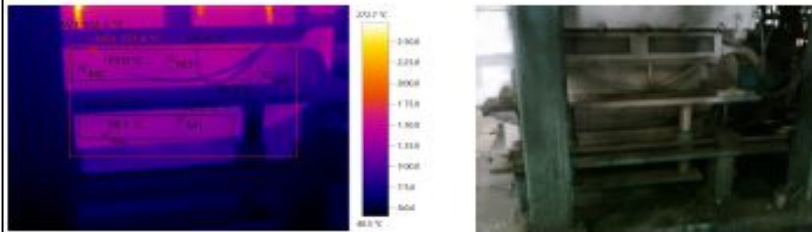
LPDC HF 3 Without Coating

File: 7 BEFORE IR001108 LPDC HF 3 HEATER JUNCTION BOX & ITS ABOVE AREA.BMT Date: 09-10-2017
 lens type: 35° x 25° lens serial no.: Time: 12:39:03

Measurement Objects	Temp. [°C]	Emiss.	Refl. temp. [°C]	Remarks
Measure point 1	95.8	0.96	20.0	CenterSpot
Measure point 2	103.0	0.96	20.0	-
Measure point 3	105.6	0.96	20.0	-
Measure point 4	92.0	0.96	20.0	-
Measure point 5	98.1	0.96	20.0	-
Hot spot 1	123.6	0.96	20.0	-
Average Area 1	102.3	0.96	20.0	-
Average Area 2	95.6	0.96	20.0	-

Location	Before Coating	After Coating	Reduction in Temperature
Heater Junction Box & Above Area Max Temp	123.6°C	107.1°C	16.5°C
Heater Junction Box & Above Area Average Temp	99.0°C	76.9°C	22.1°C

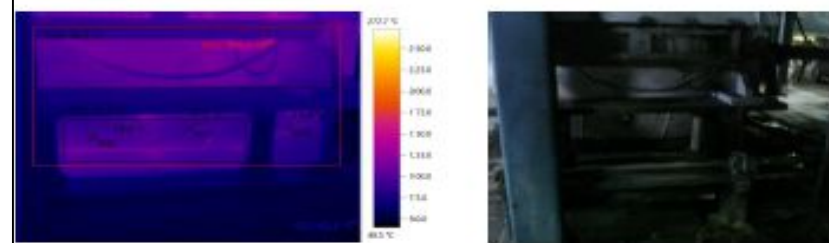
LPDC HF 2 With Coating

File: 8 AFTER IR003479 LPDC HF2 HEATER JUNCTION BOX & ITS ABOVE AREA.BMT Date: 14-03-2018
 lens type: 35° x 25° lens serial no.: Time: 17:16:21

Measurement Objects	Temp. [°C]	Emiss.	Refl. temp. [°C]	Remarks
Measure point 1	70.6	0.96	20.0	CenterSpot
Measure point 2	74.0	0.96	20.0	-
Measure point 3	73.8	0.96	20.0	-
Cold spot 1	42.3	0.96	20.0	-
Hot spot 1	107.1	0.96	20.0	-
Average Area 1	78.2	0.96	20.0	-
Average Area 2	75.5	0.96	20.0	-

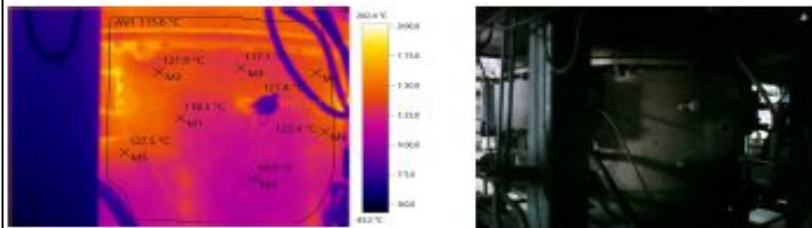
LPDC HF 3 Without Coating

File: 9 BEFORE IR001109 LPDC HF 3 BACK SIDE .BMT Date: 09-10-2017
 lens type: 35" x 25" lens serial no.: Time: 12:39:35

Measurement Objects	Temp. [°C]	Emiss.	Refl. temp. [°C]	Remarks
Measure point 1	118.1	0.96	20.0	CenterSpot
Measure point 2	121.9	0.96	20.0	-
Measure point 3	117.1	0.96	20.0	-
Measure point 4	94.9	0.96	20.0	-
Measure point 5	127.5	0.96	20.0	-
Measure point 6	123.4	0.96	20.0	-
Measure point 7	127.8	0.96	20.0	-
Hot spot 1	202.4	0.96	20.0	-
Average Area 1	115.6	0.96	20.0	-

Location	Before Coating	After Coating	Reduction in Temperature
Back Side Max Temp	202.4°C	178.1°C	24.3°C
Back Side Average Temp	115.6°C	88.5°C	27.1°C

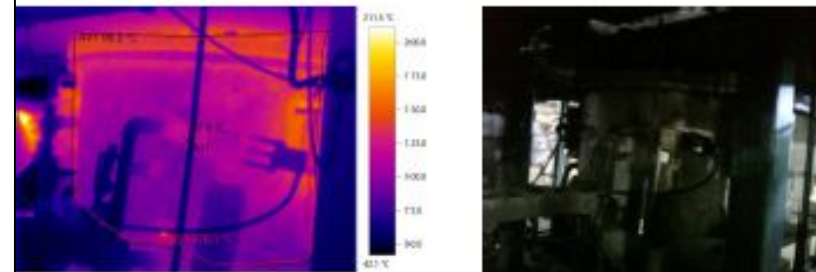
LPDC HF 2 With Coating

File: 10 AFTER IR003482 LPDC HF 2 BACK SIDE.BMT Date: 14-03-2018
 lens type: 35" x 25" lens serial no.: Time: 17:17:12

Measurement Objects	Temp. [°C]	Emiss.	Refl. temp. [°C]	Remarks
Measure point 1	95.9	0.96	20.0	CenterSpot
Cold spot 1	42.1	0.96	20.0	-
Hot spot 1	178.1	0.96	20.0	-
Average Area 1	88.5	0.96	20.0	-
